FERR CEMENT FOR CANADIAN FISHING VESSELS VOL. 3

Project Report No.55

FERRO-CEMENT

FISHING VESSEL CONSTRUCTION III

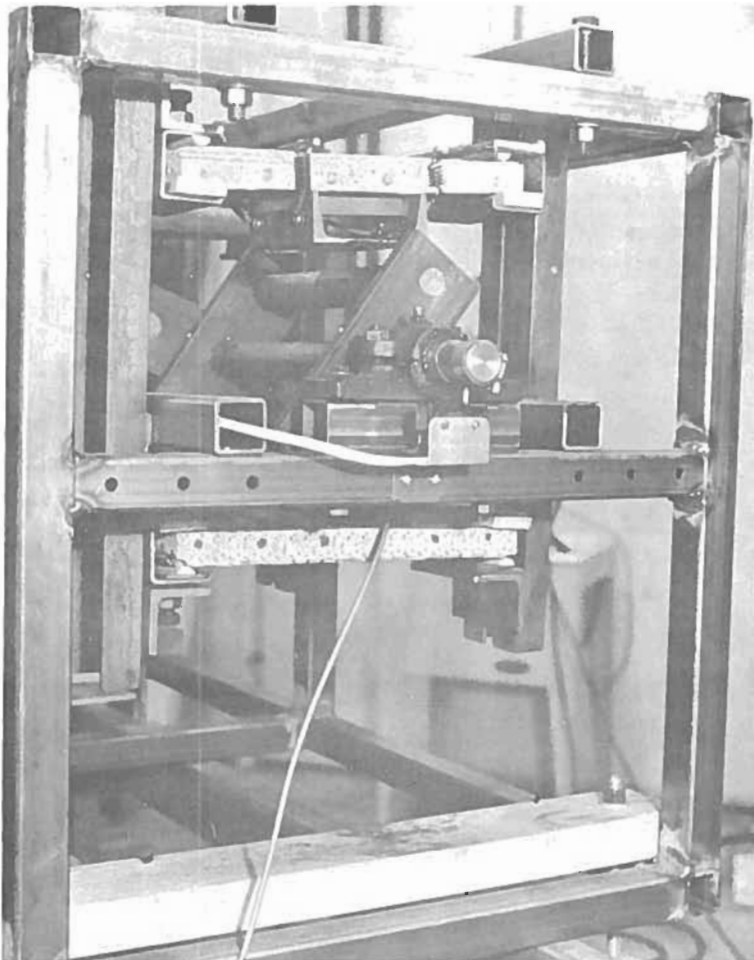
Fig. 2.

Beam specimens
and load cells
in cyclic flexure
test apparatus.

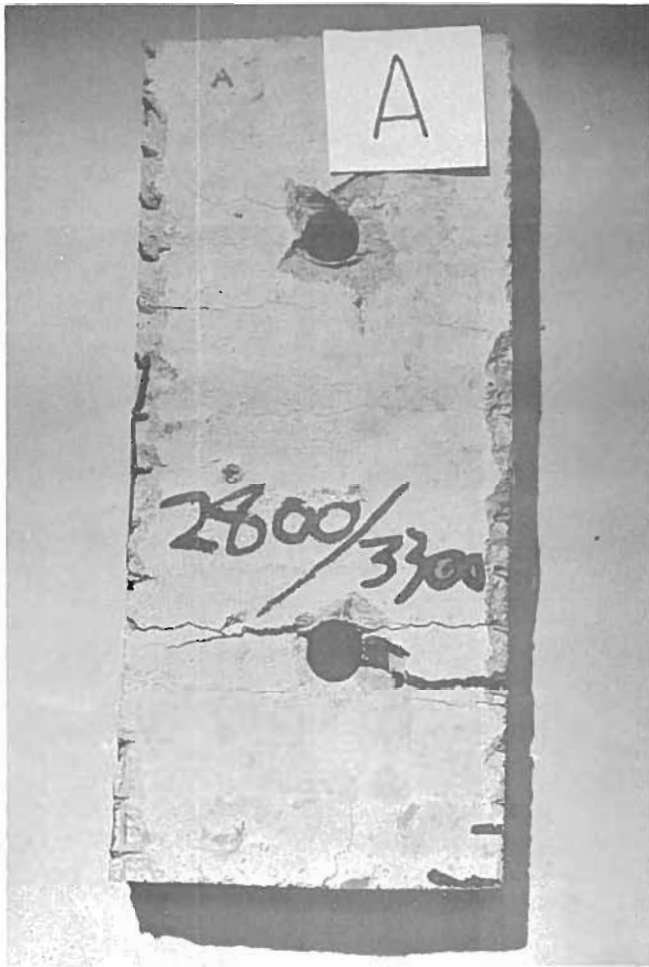
Fig. 13.

Bolting failure in
Type A specimens.

The test results presented in Table 4 show that a hole distance of two inches from the free edge is adequate to prevent failure by edge breakout when the specimen width (bolt hole spacing) is four inches. A hole distance of four inches from the free edge is necessary to prevent edge breakout when the specimen width (bolt hole spacing) is eight inches. Fig. 13 to 16 show typical failures.

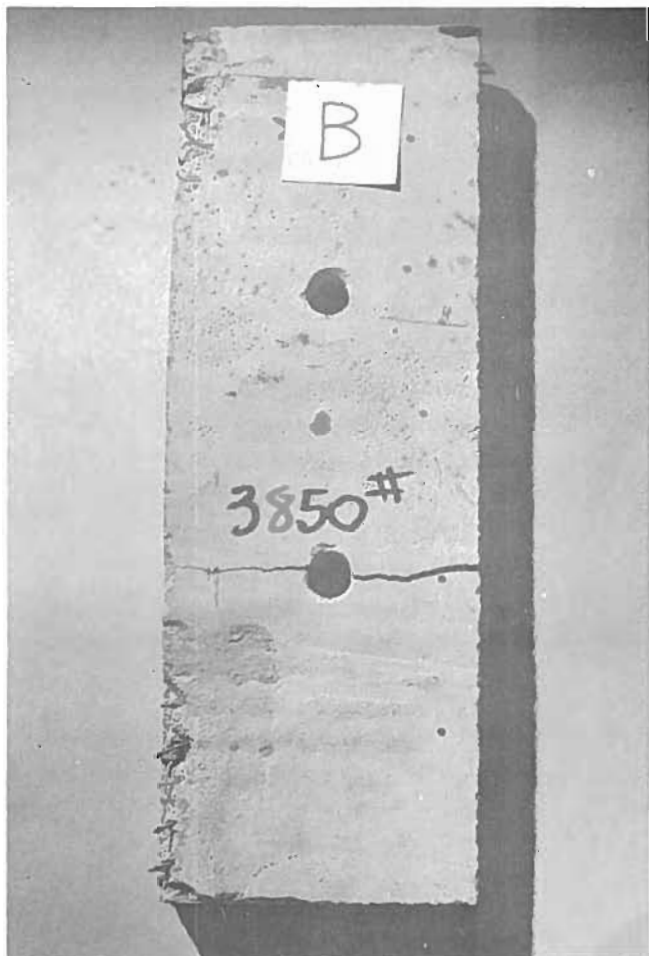
Fig. 14.

Bolting failure in
Type B specimens.

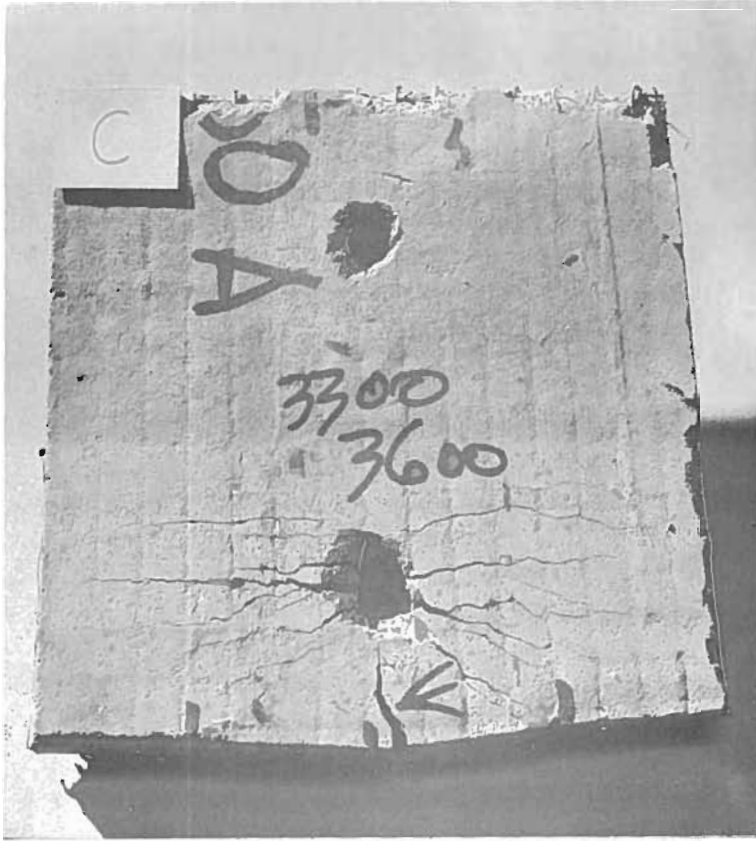
Fig. 15.

Bolting failure in
Type C specimens.

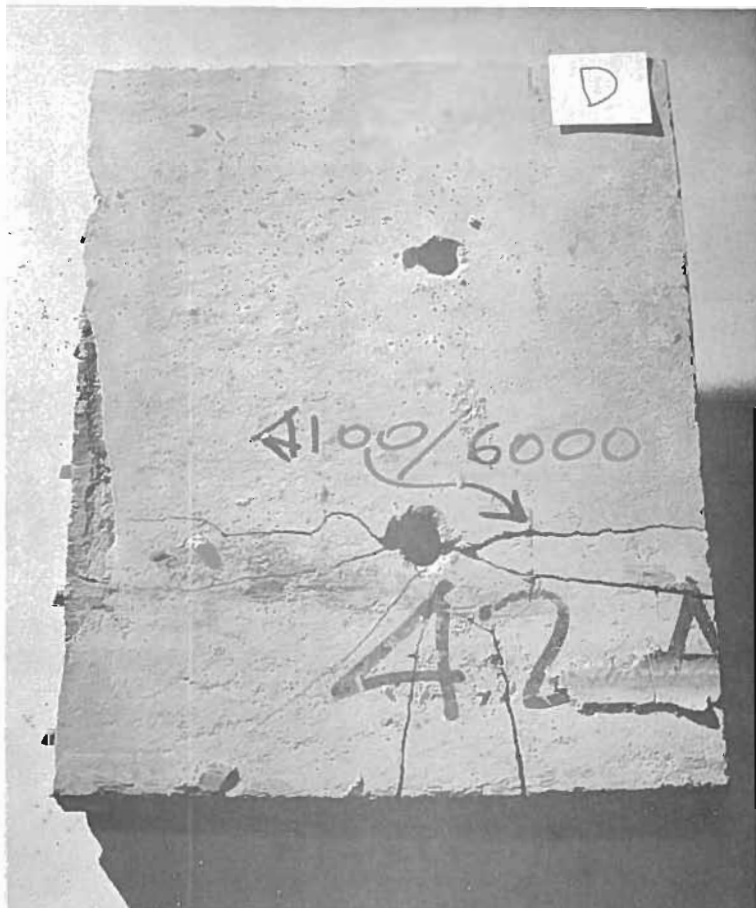
Fig. 16.

Bolting failure in
Type D specimens.

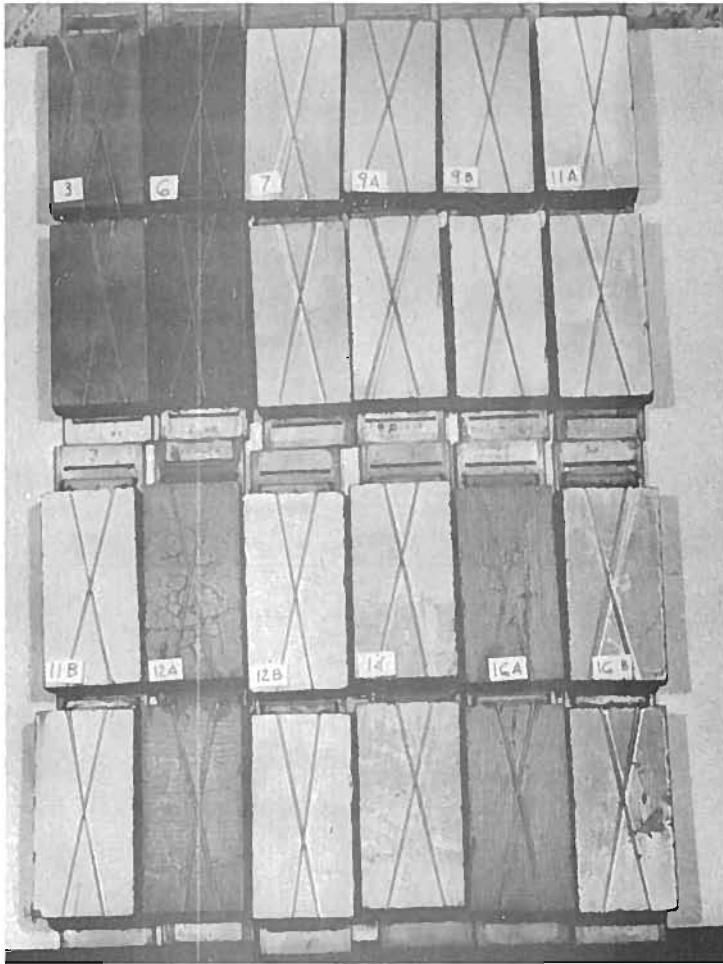
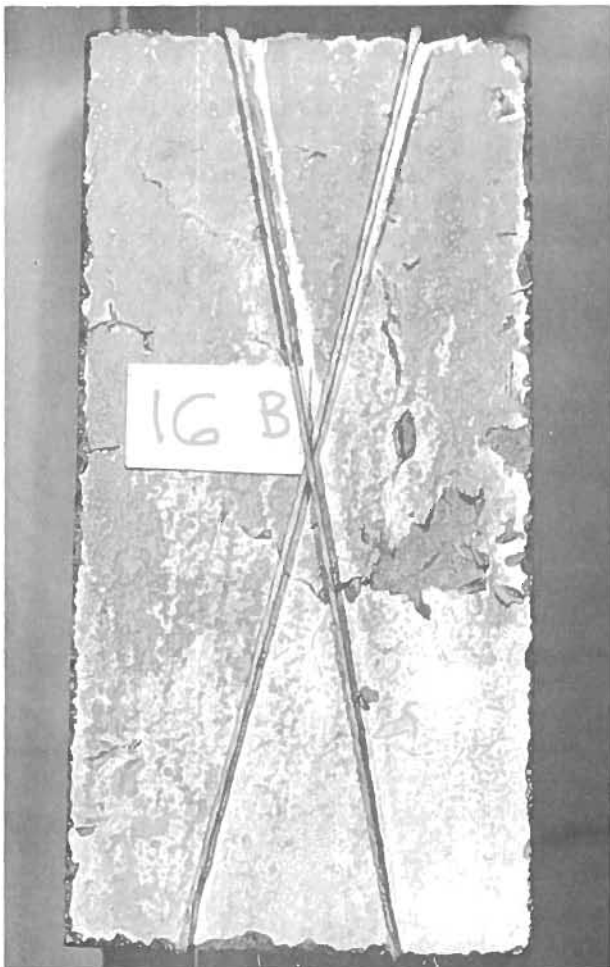
Figs. 20 and 21.

**Specimens removed
from Weather-Ometer
after 1500 hrs
exposure.**

regular intervals. Flaking of the coating in one of the specimens from panel 16B was observed after an equivalent exposure of 5 years, Fig. 20 and 21. The observations after 1500 hr (6 years) are recorded in Table 9.
